## Corrosion Resistant Products

CHEMICAL RESISTANT FLOORING  
 FLOOR LEVELING & PITCHING  
 TANK REPAIR & INSPECTION  
 TURNKEY CAPABILITIES

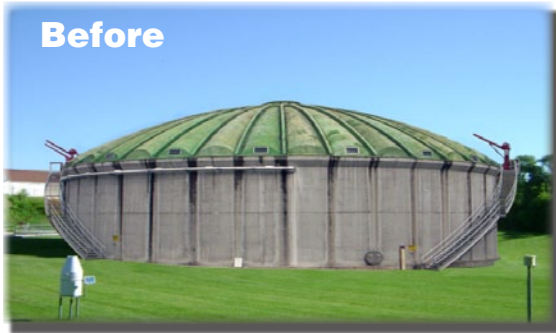
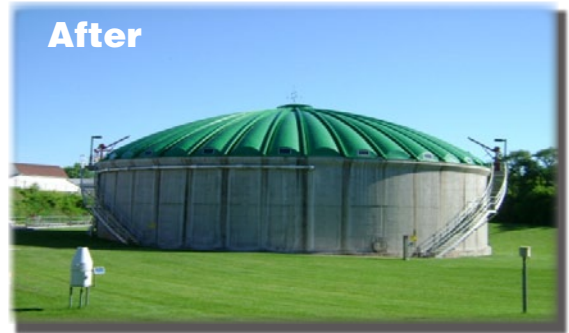
## Dome Cover

A local wastewater treatment plant had a fiberglass dome cover in need of repair, showing signs of delamination and deterioration - common problems when exposed to the elements.

To solve this problem, the initial step was to remove the deteriorated coatings. A combination of waterblasting and sandblasting effectively cleaned the surface and prepared the dome for its new coating. Next, an epoxy primer was laid down as a base, promoting adhesion to the UV resistant polyurethane top coat to ensure long lasting protection.

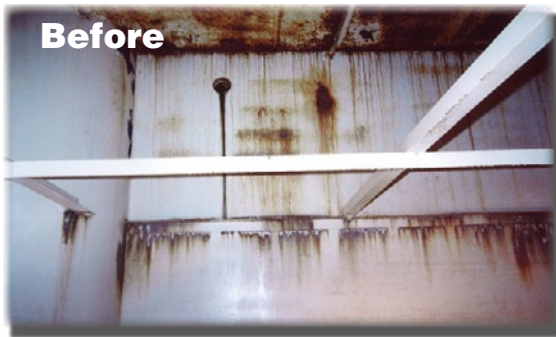
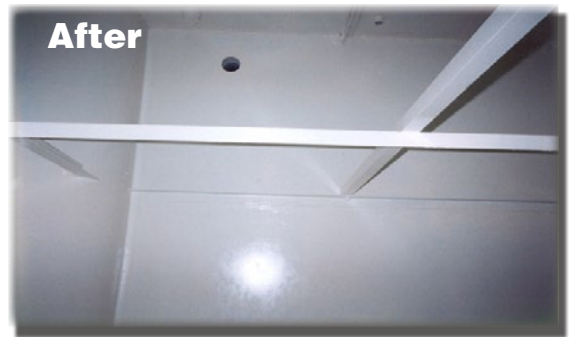
## Tank Lining

After many years of service, the corrosive effects of this food ingredient had clearly taken its toll; the tank needed a new lining. During a scheduled downtime and under confined space requirements, Crane Engineering got to work.

The first step, was to sandblast the lining - removing all traces of rust and corrosion. Once the surface was clean, FDA approved 7133 epoxy was used to coat the tank and supporting angle iron, bringing this restoration project to an end. Installation was completed within the scheduled timeframe and was ready for use when production resumed.

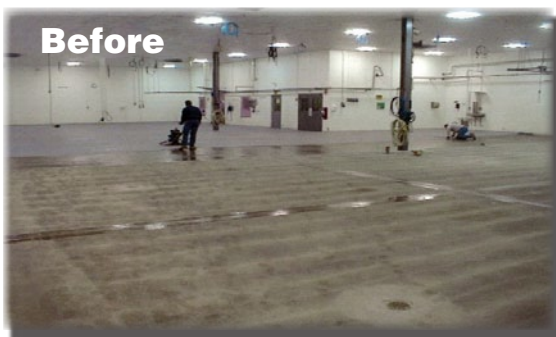
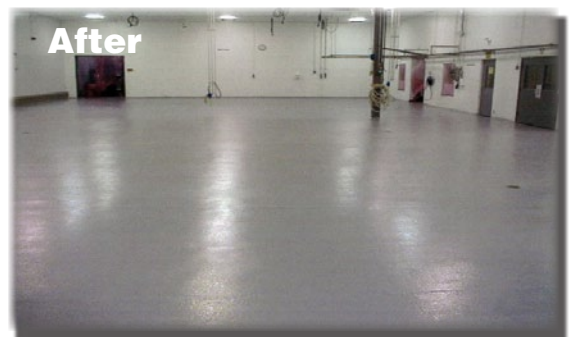
## Flooring

This 7000 square foot packaging room at a local food manufacturer needed to be redone and made FDA compliant. A scheduled downtime once again provided the opportunity to get started.

The existing coating needed to be removed and was shotblasted to provide a clean, sound substrate for adhesion. Due to the amount of traffic, a 1/4 inch non-skid floor was installed to minimize slippage and promote safer working conditions. Finally, a 100% solids polymer sealer was used to create a seamless surface - making it easy to clean and maintain.
