CORROSION RESISTANT PRODUCTS

*Chemical Resistant Flooring | Floor Leveling & Pitching
Tank Repair & Inspection | Turnkey Capabilities*

REPAIR JOBS

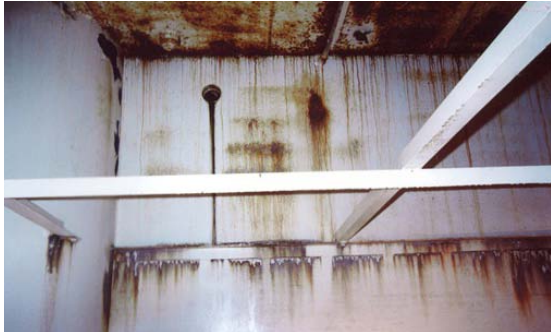
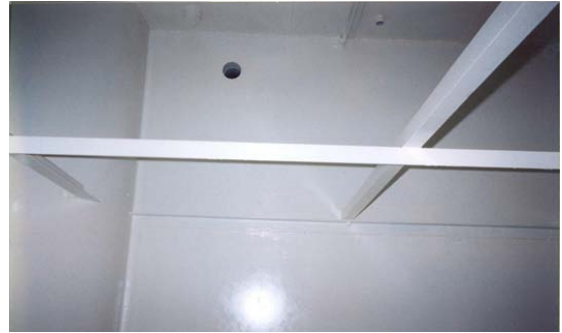
Tank Lining

After years of service, the corrosive effects of this food ingredient had taken its toll. The tank needed a new lining. During a scheduled down, and under confined space requirements, Crane Engineering got to work.

First, the lining was sandblasted to remove all traces of rust and corrosion. Once the surface was clean, FDA approved 7133 epoxy coated the tank and supporting angle iron, bringing this restoration project to an end. Installation was completed within the scheduled timeframe and the tank was ready for use when production resumed.

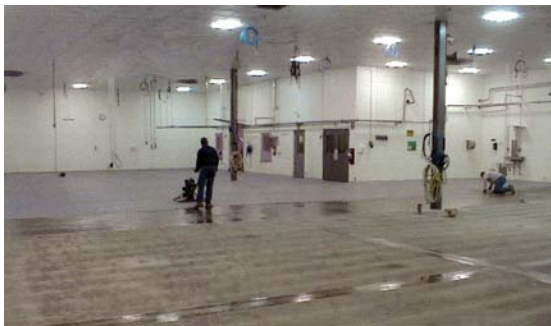
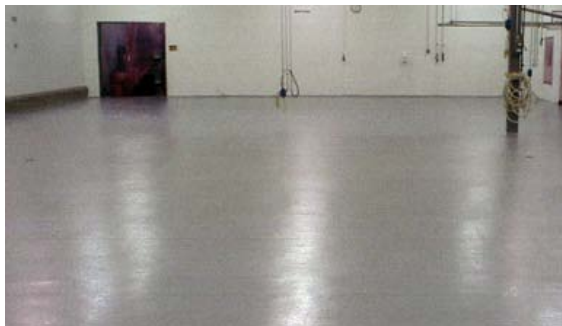
Flooring

This 7000 square foot packaging room at a local food manufacturer needed to be FDA compliant. A scheduled downtime provided the opportunity to get started.

The existing coating needed to be removed. Shot blasting the surface provided a clean, sound substrate for adhesion. Due to the amount of traffic, a 1/4" non-skid floor was installed to reduce slippage and promote safer working conditions. Finally a 100% solids polymer sealer was used to create a seamless surface - making it easy to clean and maintain.

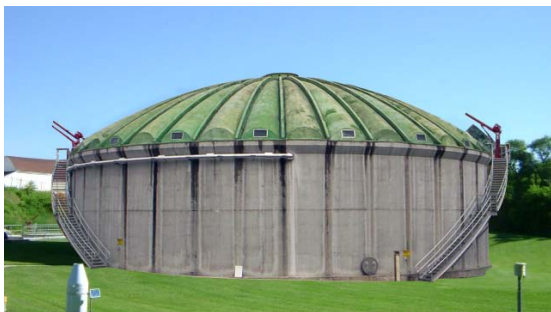
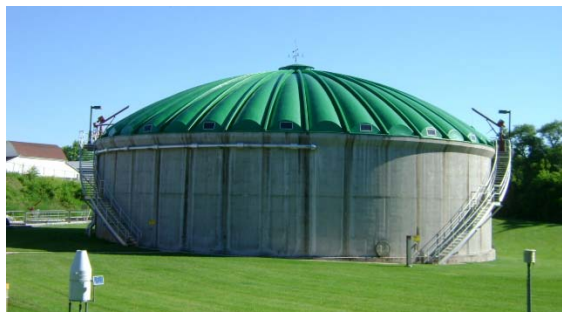
Dome Cover

A fiberglass dome cover at a local wastewater treatment plant was in desperate need of repair. It showed signs of delamination and deterioration - common problems when exposed to the elements.

To begin restoration, the deteriorated coatings were removed. A combination of waterblasting and sandblasting cleaned the surface and prepared the dome for its new coating. Last, an epoxy primer was applied as a base, promoting adhesion to the UV resistant polyurethane top coat while ensuring long lasting protection.
